5.2. Command Subsystem.

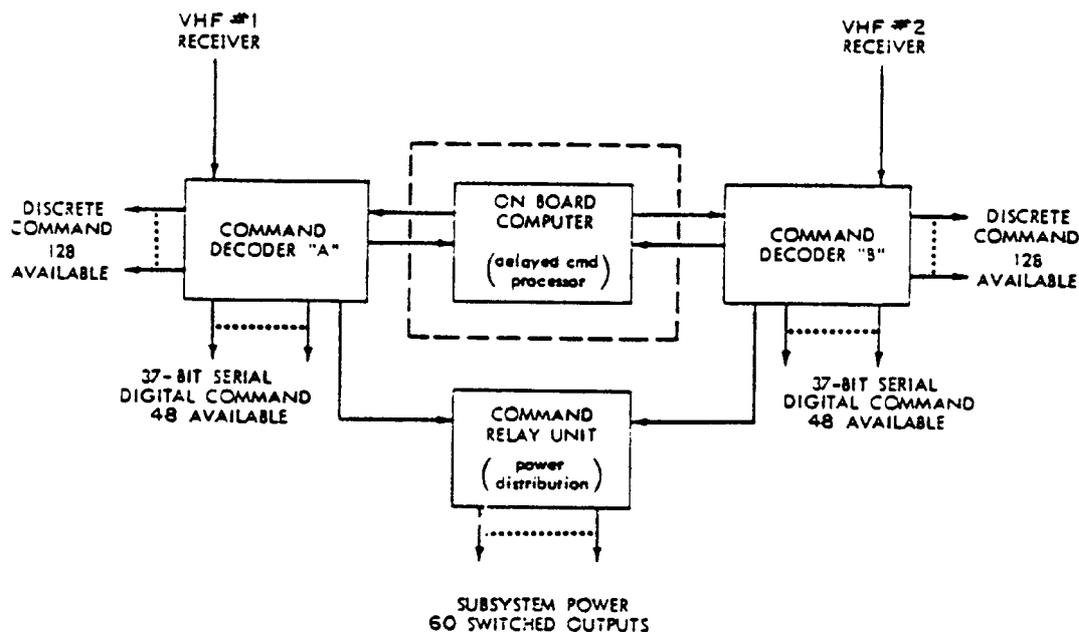
Figure 5-18. IUE Command Subsystem Block Diagram.

The IUE command subsystem consists of redundant command decoders and a command relay unit (CRU), as is shown in the figure 5-18. The CRU contains circuit redundancy up to the individual relay and relay driver stage. Three types of commands are available; impulse and serial commands are distributed by decoders 1 and 2, and relay closures are provided by the CRU.

Each command decoder can process command messages from two sources: a VHF receiver analog signal and digital information from the OBC.

The command decoder contains three distinct circuit groups: analog circuits, digital logic circuits and dc/dc converter. The analog circuits demodulate the input signal and convert the information contained to three digital output signals which are data, voltage-controlled oscillator (VCO) clock and a data present signal. The first two signals transfer the uplink command information to the digital logic circuits for processing, while the last one allows the digital logic to proceed with command processing only when adequate bit error rate probability exists. The digital logic circuits
